**Subject:** Premature protection, thermal or amplifier failure

**Brand:** Rockford Fosgate - Punch and Power Series

**Bulletin No.:** SrvAdvise-02

**Date Issued:** July, 2005

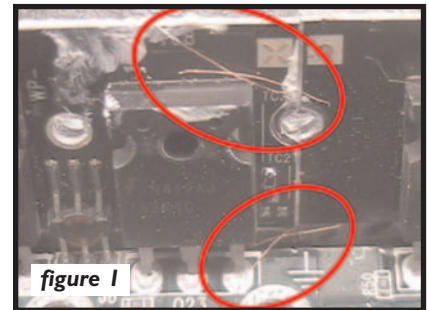
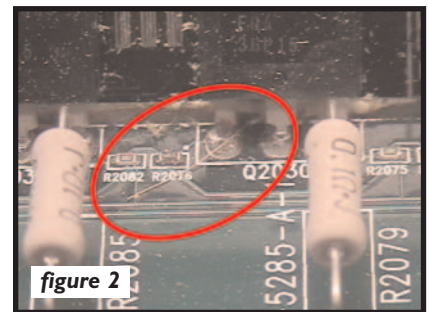
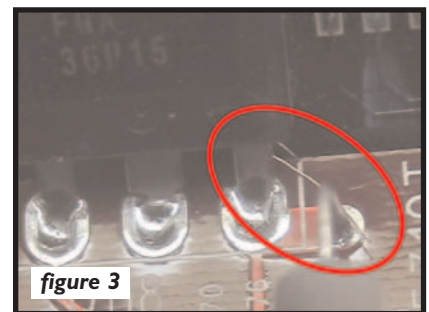
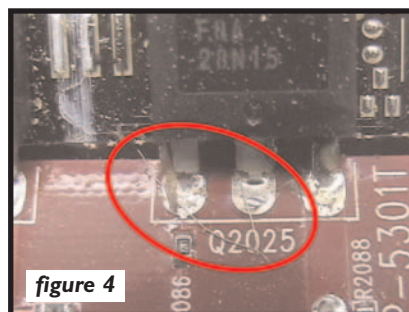
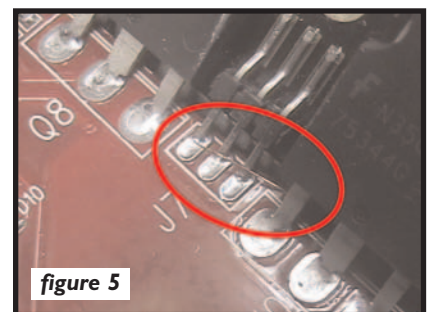
Some amplifiers were found with strands of wire inside of them that have caused a short, see figures 1-5. This in turn has caused the amp to go into one of the protect modes or to fail.

**Solution:** When installing any Rockford Fosgate amplifier do not cut or strip any wires over or near the amplifier. Cover the amplifier with a towel when you have to cut or strip wires near it. Both of these will help prevent the possibility of wire strands getting inside of the amplifier and possibly cause a problem.

After installation, always vacuum up any loose material, wire strands and such, that may enter the amplifier at a later time
